Summary of Chevron Guadalupe Restoration Project

This document provides a summary of the Guadalupe Restoration Project, including background information on the project, clean up and restoration work that has been completed to date, and what work is still outstanding at the site.

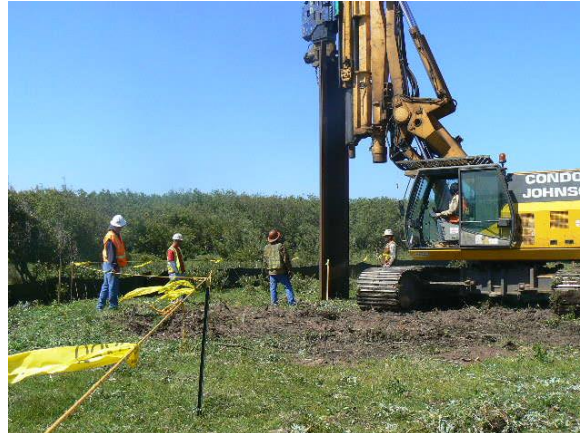
Sheetpile Installation

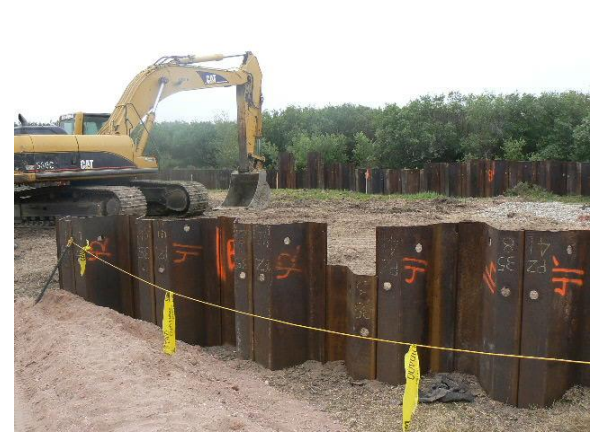
Excavation

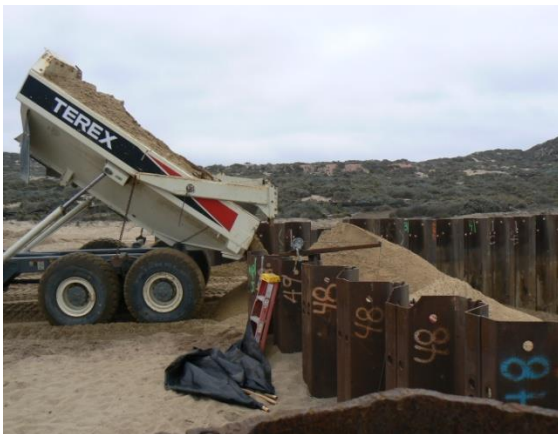
Backfill

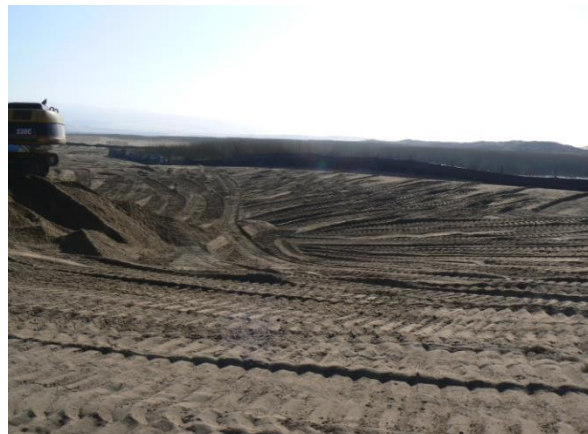
Recontouring Final

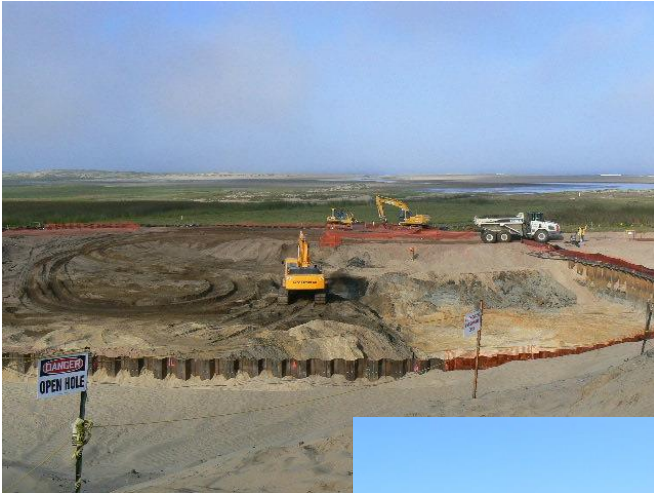
**B12 Wetland
Excavation December
2007**

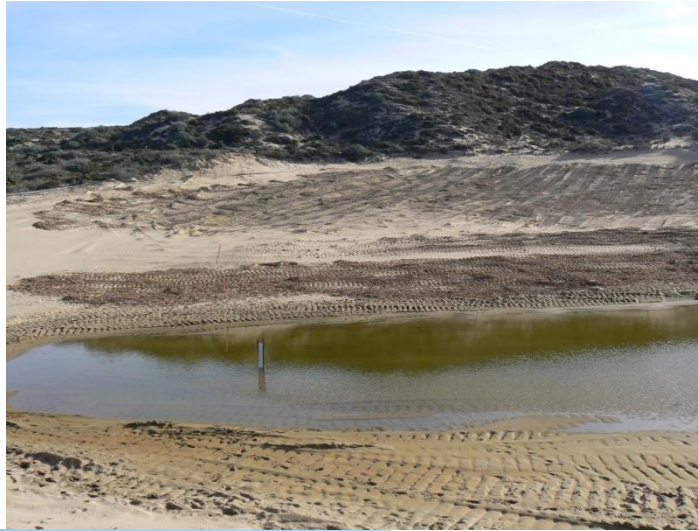
B12 Wetland Final Grade January 2008

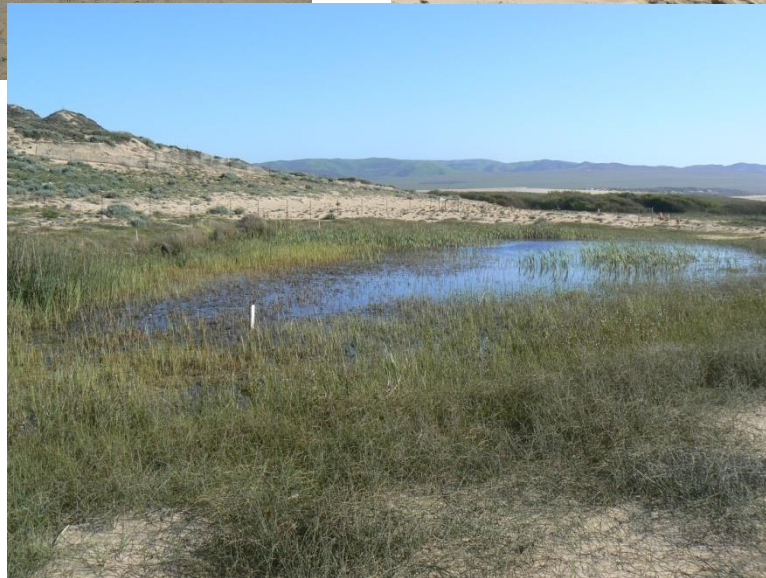
**B12 Wetland Created
February 2010**

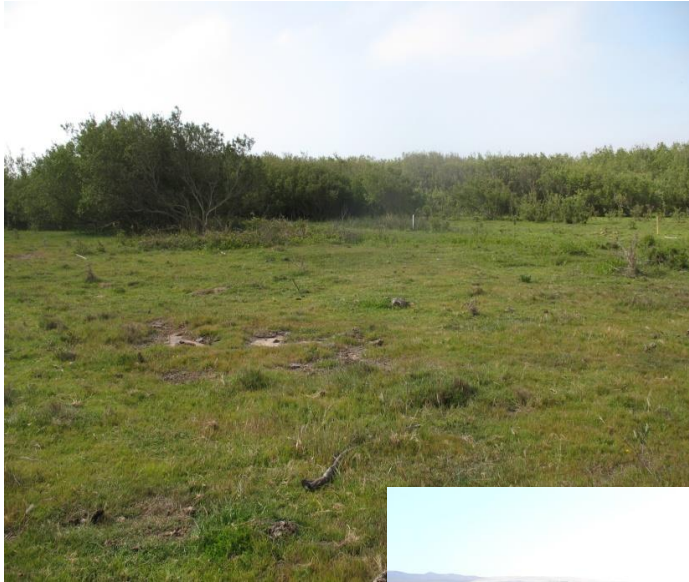
**D14 Pad Site: pre-excitation,
June 2007.**

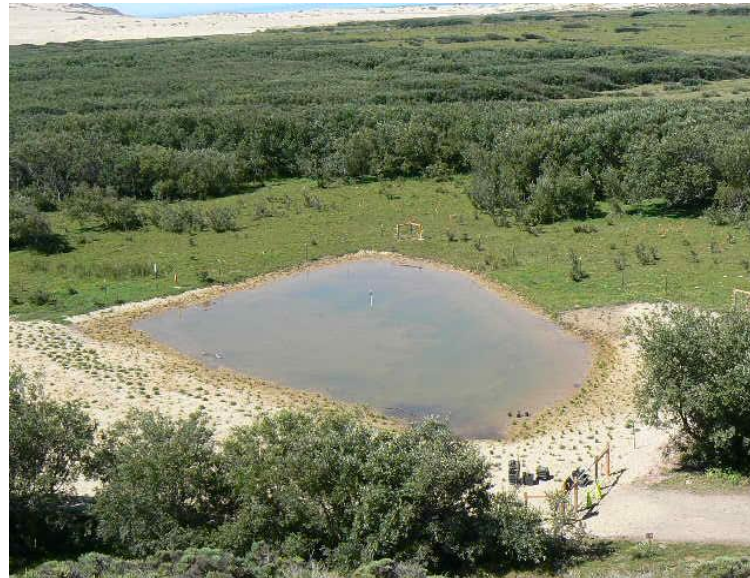
**D14 Site: post-excitation
Final Grade, July 2007**

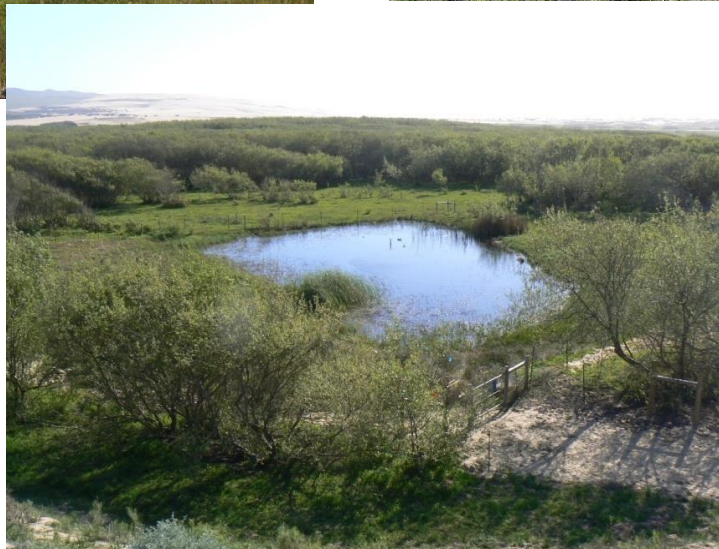
**D14 Restoration Site: post
excavation, February 2010.**
